CEMENT-BASED MATERIALS IN CONTACT WITH WATER – REACTIVE TRANSPORT DRIVEN BY SURFACE PROCESSES –

M. Schwotzer¹, T. Scherer², A. Gerdes^{1,3}

¹ Forschungszentrum Karlsruhe, ITC-WGT

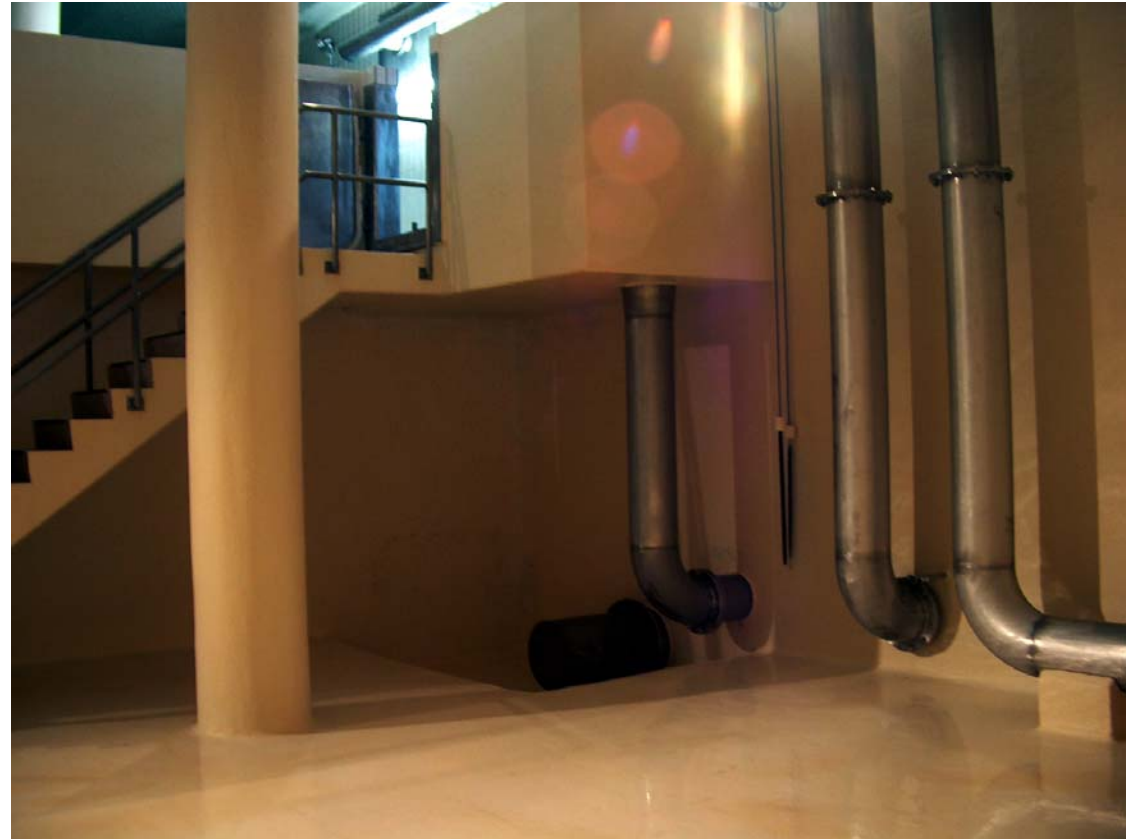
Observations in tap water reservoirs

Deterioration of cement-based materials during service life in contact with hard tap water (in carbonic acid equilibria)

Appearance:

- brown spots
- strictly local
- sometimes arranged in regular patterns

Mechanical properties:

loss of strength

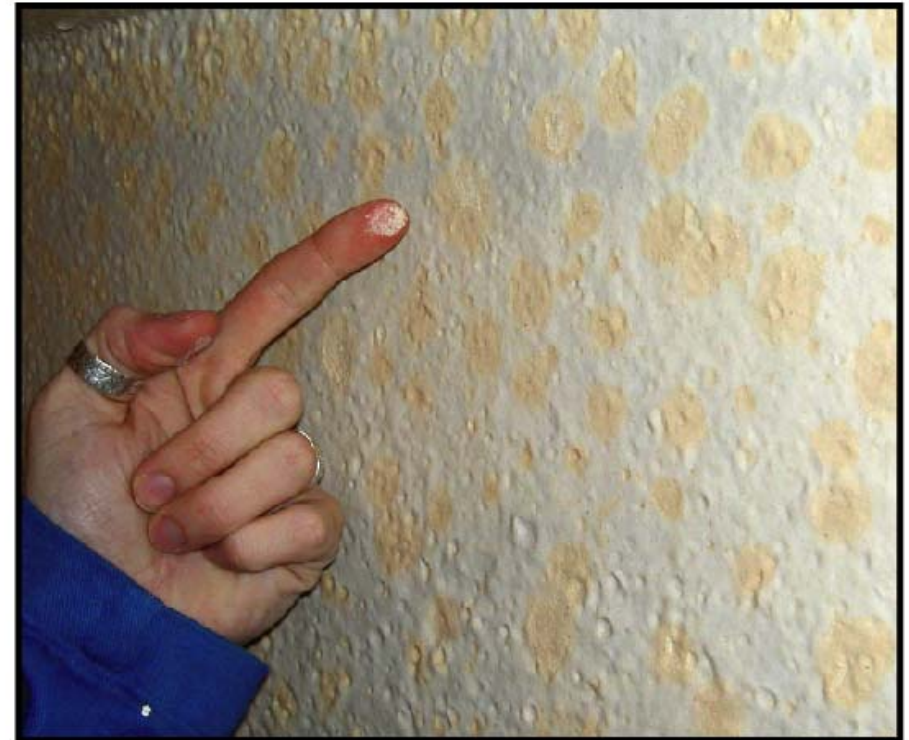
Observations in tap water reservoirs

Chemistry:

- discharge of $\text{Ca}(\text{OH})_2$
- „intrusion“ of CaCO_3
- degradation of CSH

Kinetics:

Sometimes 6 months after application in permanent „contact“ with hard tap water: lateral- and depth-expansion of the damage

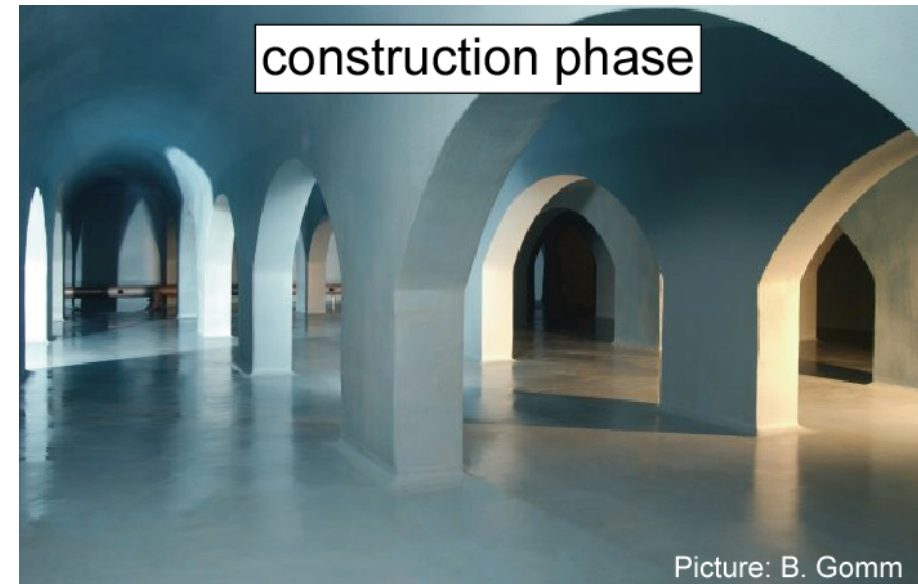
Experimental setup to characterize the cement paste/ water interaction, based on practical frame conditions

- Fresh cut slices (1 mm) of white cement paste ($w/c=0,4$)
- Temperature = 11°C

Different types of exposition:

Water

- demineralized water
- hard drinking water

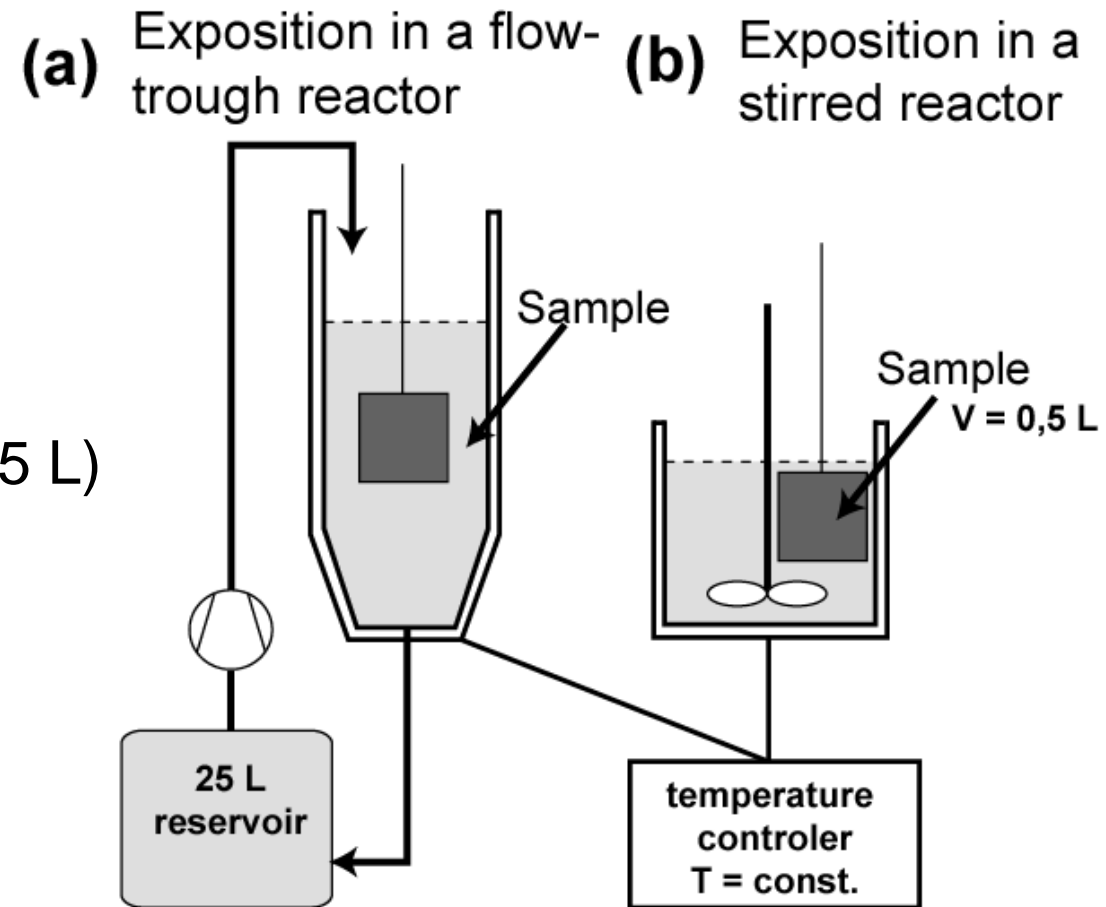
Basic conditions

- continuous water exchange ($V=25\text{ L}$)
- stirred ($V=0,5\text{ L}$), open system

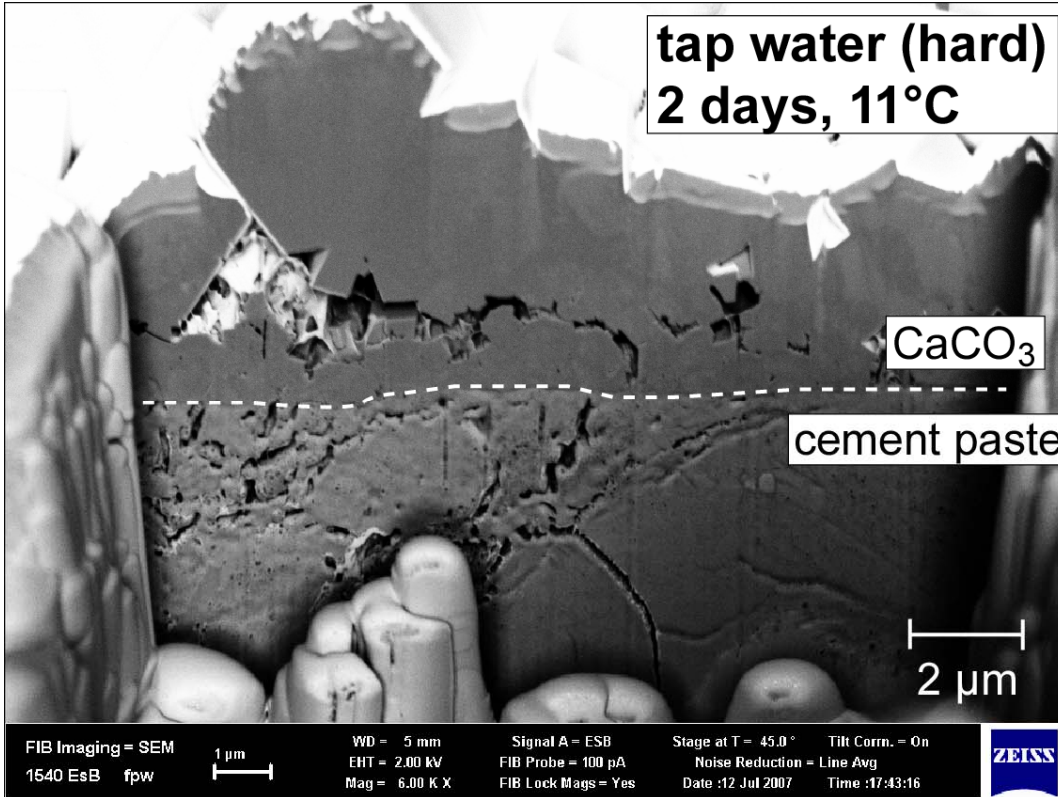
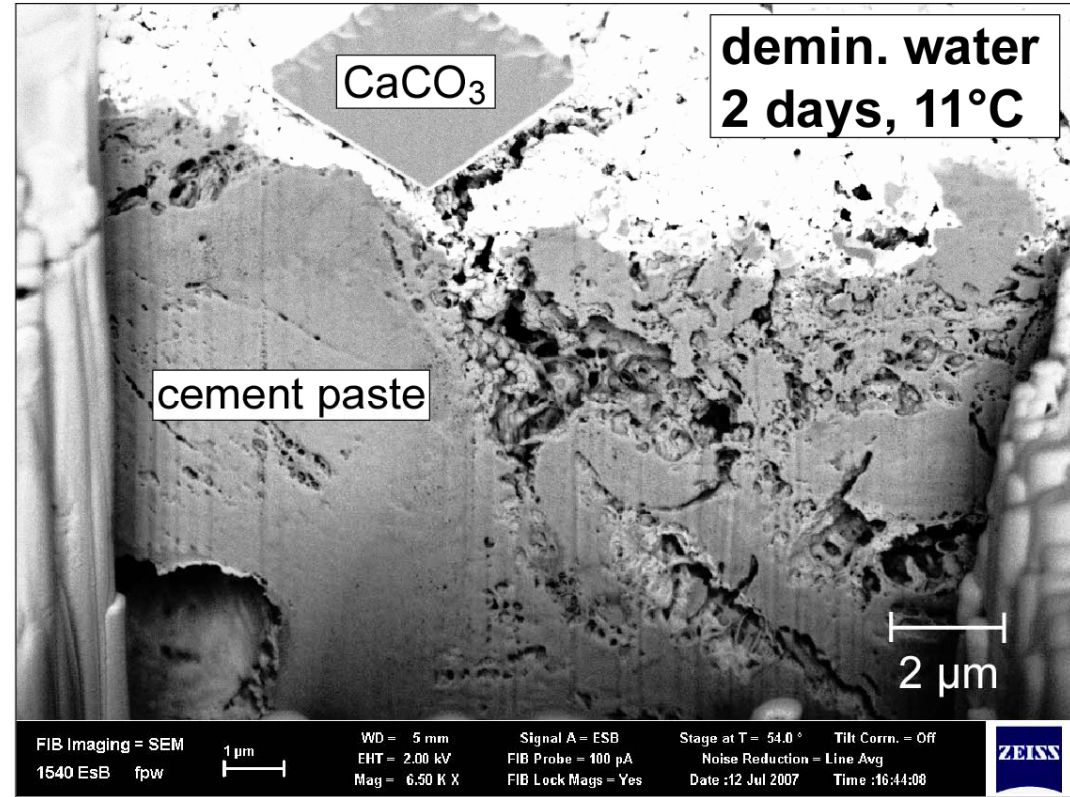
Focused Ion Beam cuts

What happens at the material/water interface?

Contact with hard tap water:

- development of a covering CaCO₃-layer
- no significant impact on pore structure and chemical composition

Contact with demineralized water:

- No dense covering CaCO₃-crystallization
- Chemical attack on the cement paste
 - leaching
 - enlargement of the pore structure

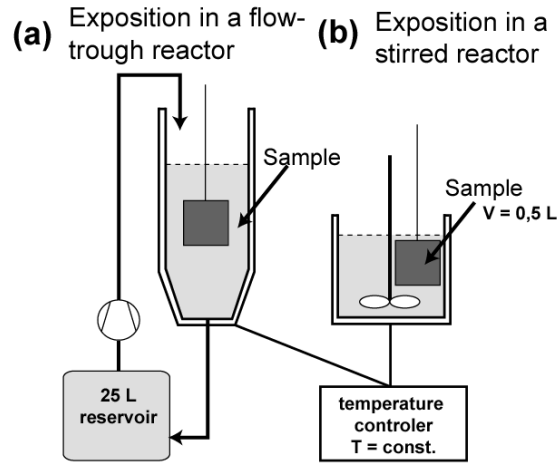
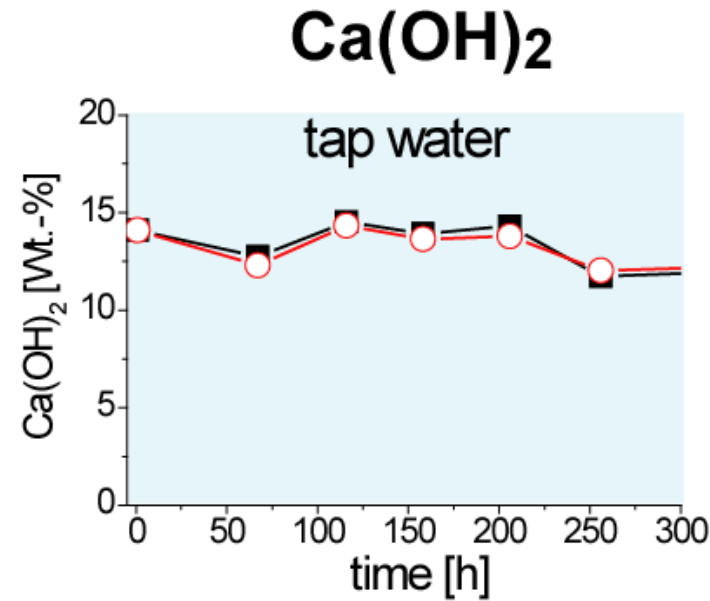
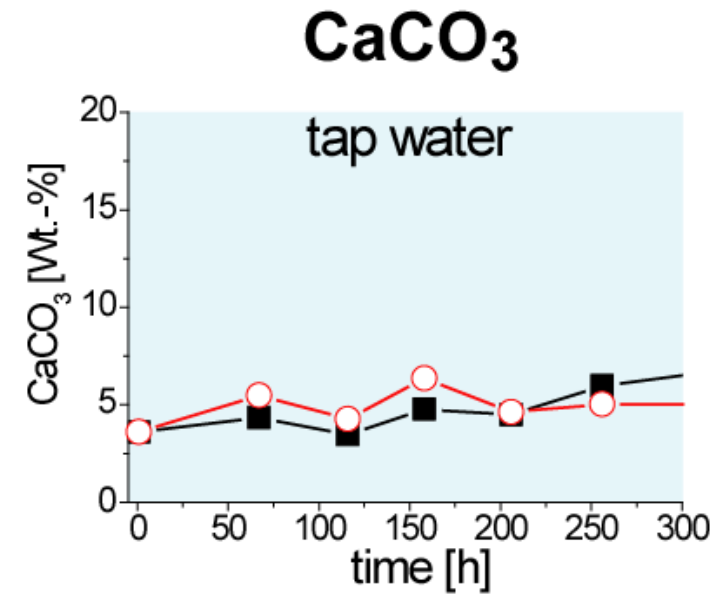
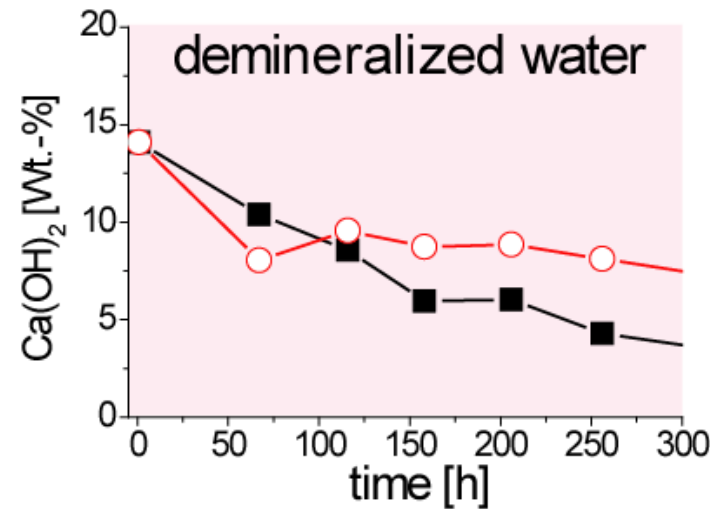
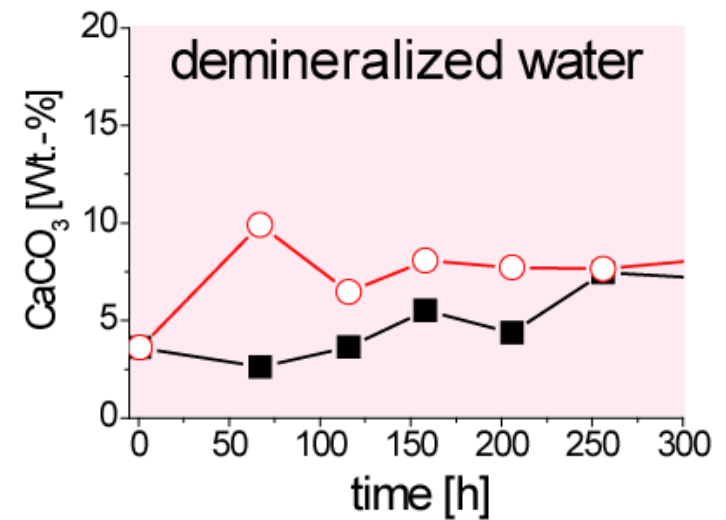
Calcite and portlandite content vs. time

cont. water exchange, 25 L

stirred, 0,5 L

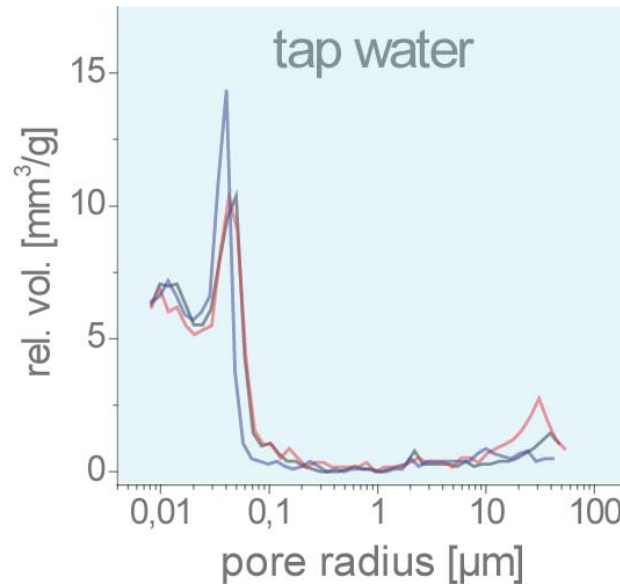
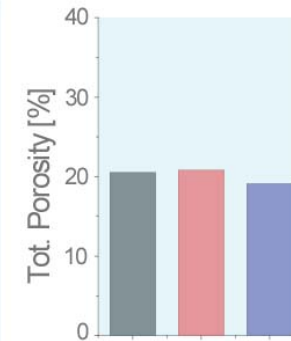
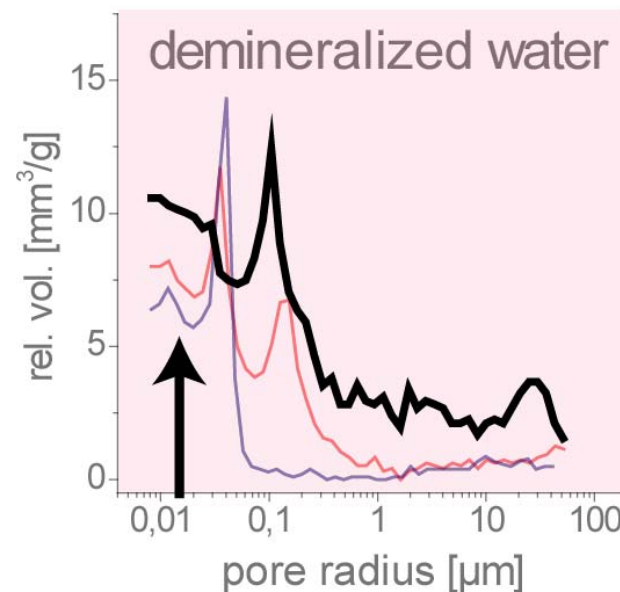
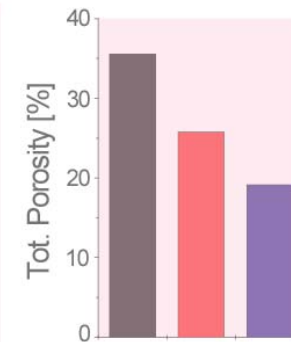
Porosity and pore size distribution

Hard tap water:

no significant change in porosity and pore size distribution

Demineralized water:

Increase of porosity and changes in pore size distribution

Increase in the smallest pore volumes

indicates that the paste is changing in ways other than just being destroyed, which would tend to decrease the surface area /fine structure.

— cont. water exchange (25 L), 10 days
— stirred (0,5 L), 10 days
— reference

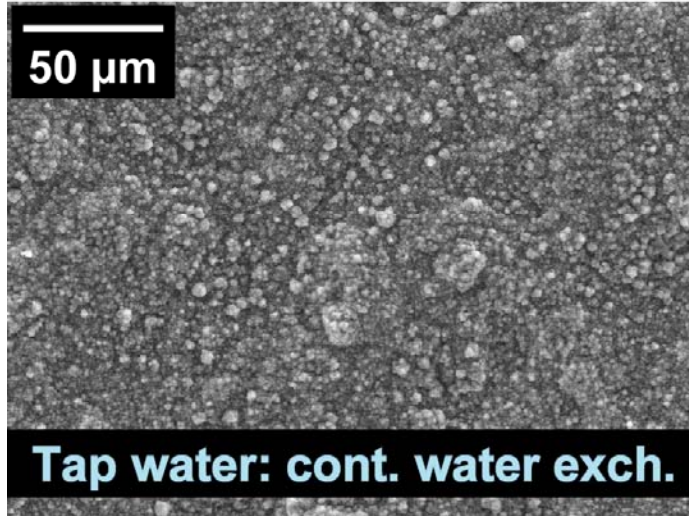
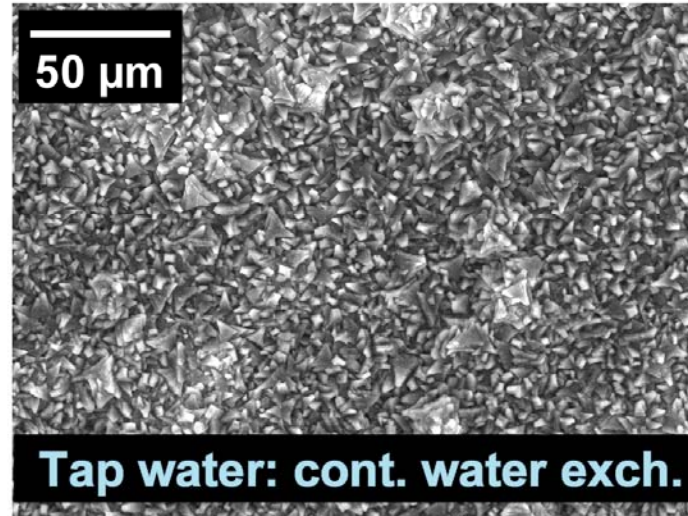
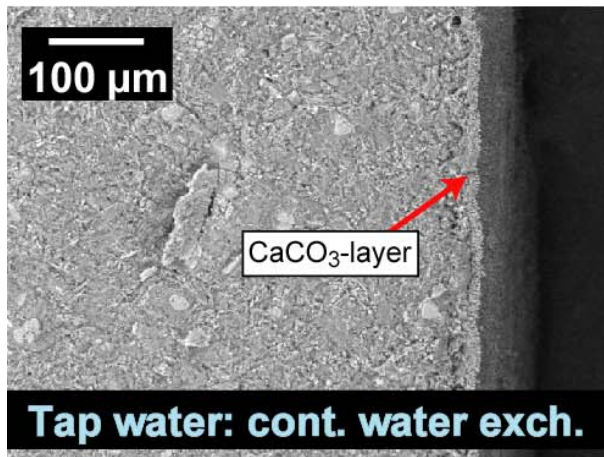
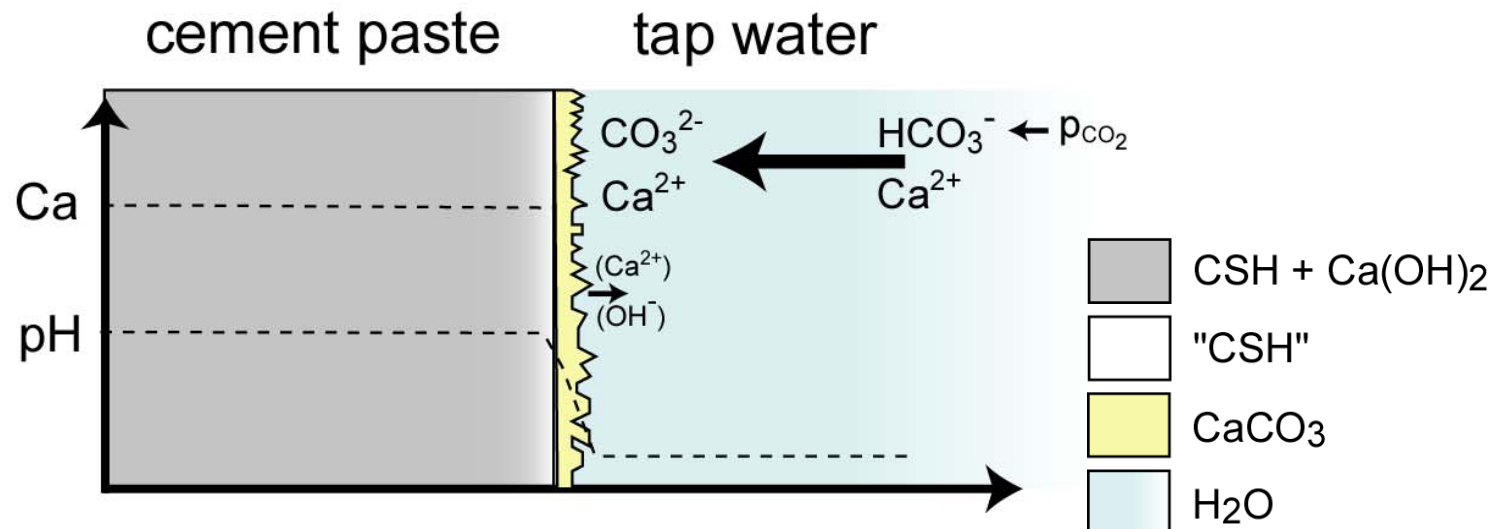
Surface processes in hard tap water

→ Cont. water exchange (25 L reservoir), tap Water: HCO_3^- available

3 days

10 days

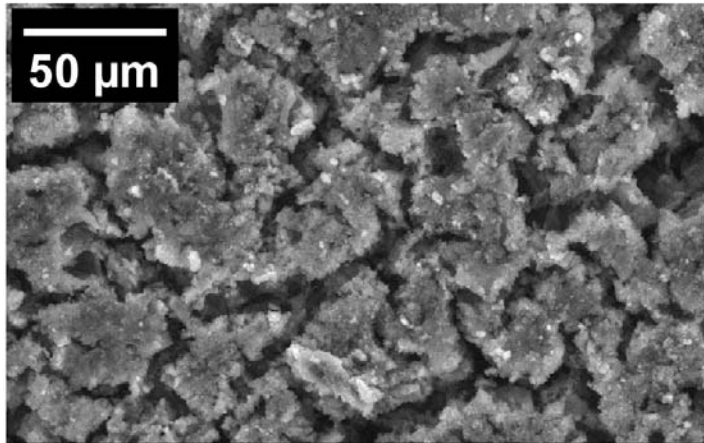
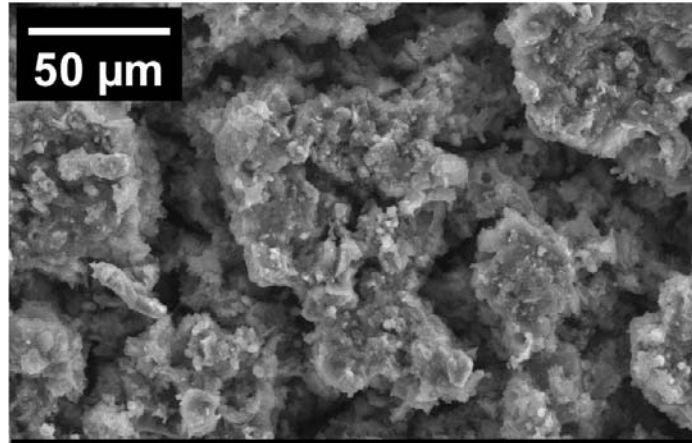
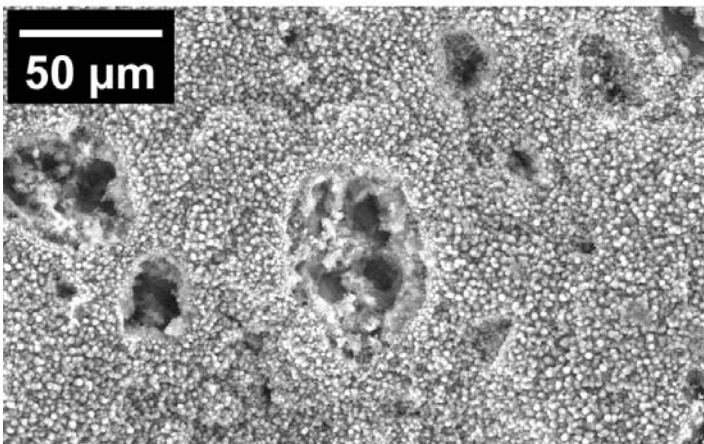
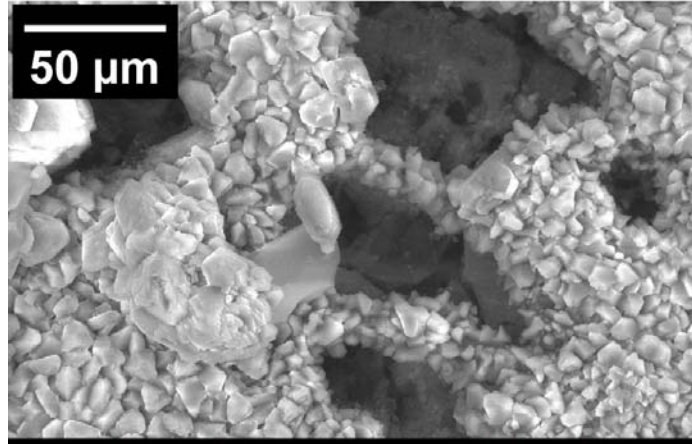
Demin. water: cont. water. ex.

Demin. water: stirred

Demineralized water:

- Ca-leaching from the CSH-gel is associated with a decrease of volume
- „Decalcification shrinkage“ (Chen et al., 2006) leads to the formation of micro-cracks in the surface zone of the material
- In the stirred reactor: CaCO_3 overgrows the „leaching“ features

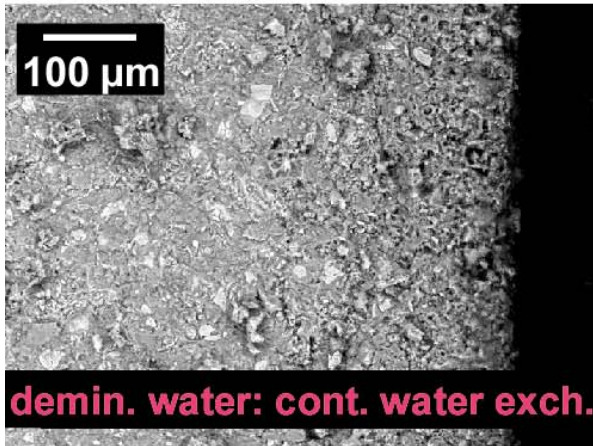
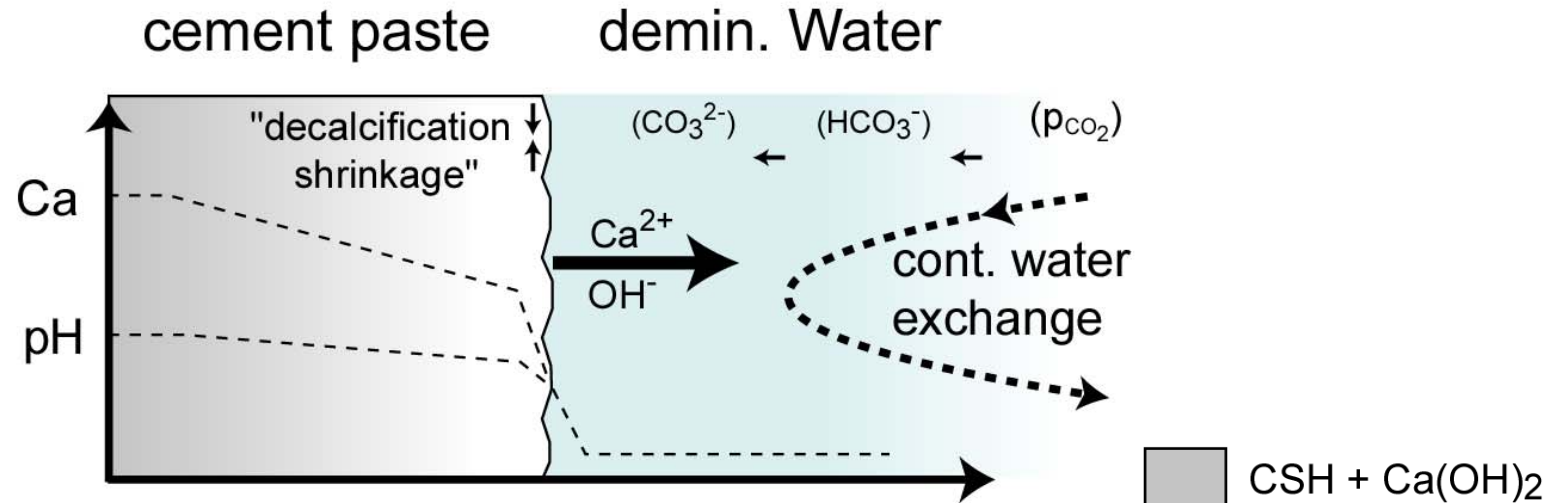
Reaction with demineralized water

→ Cont. water exch. (25 L reservoir), demineralized Water: **low CO₂ availability**

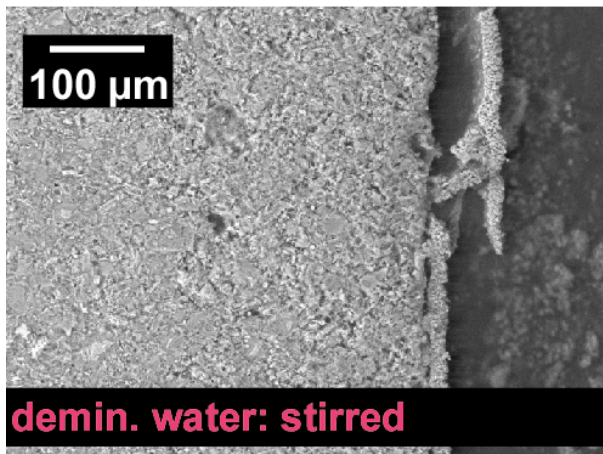
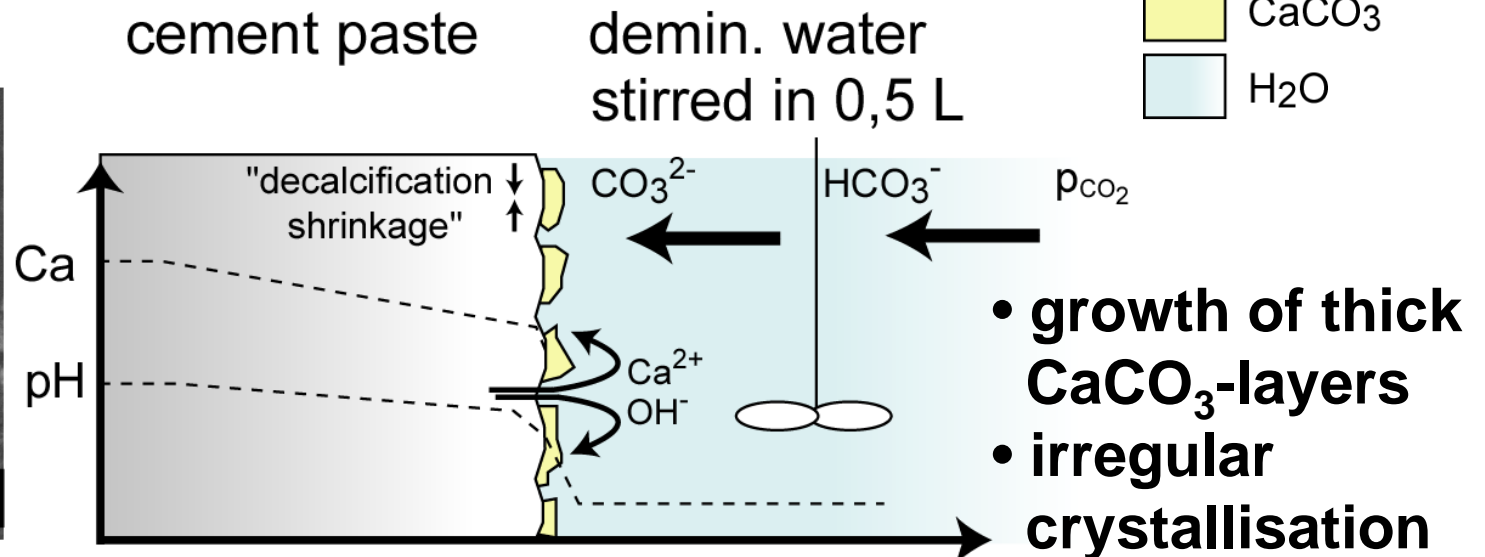
Stirred reactor (0,5 L) → **good CO₂ availability**

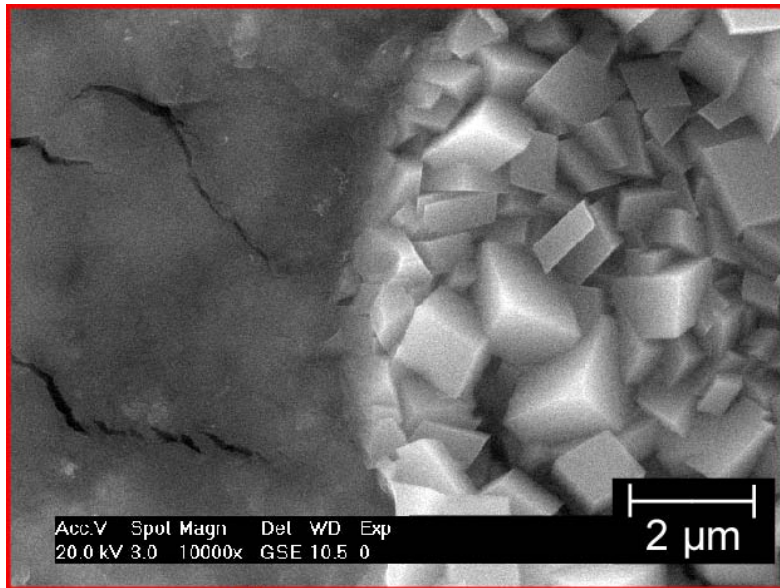
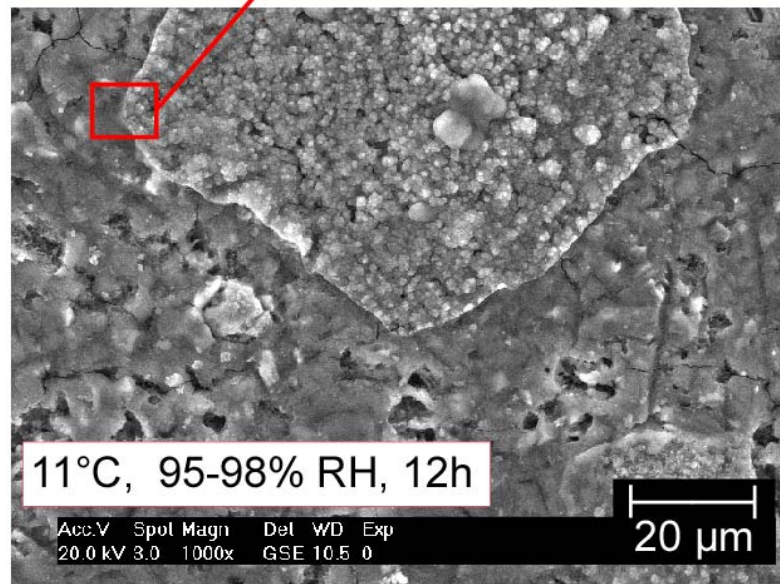
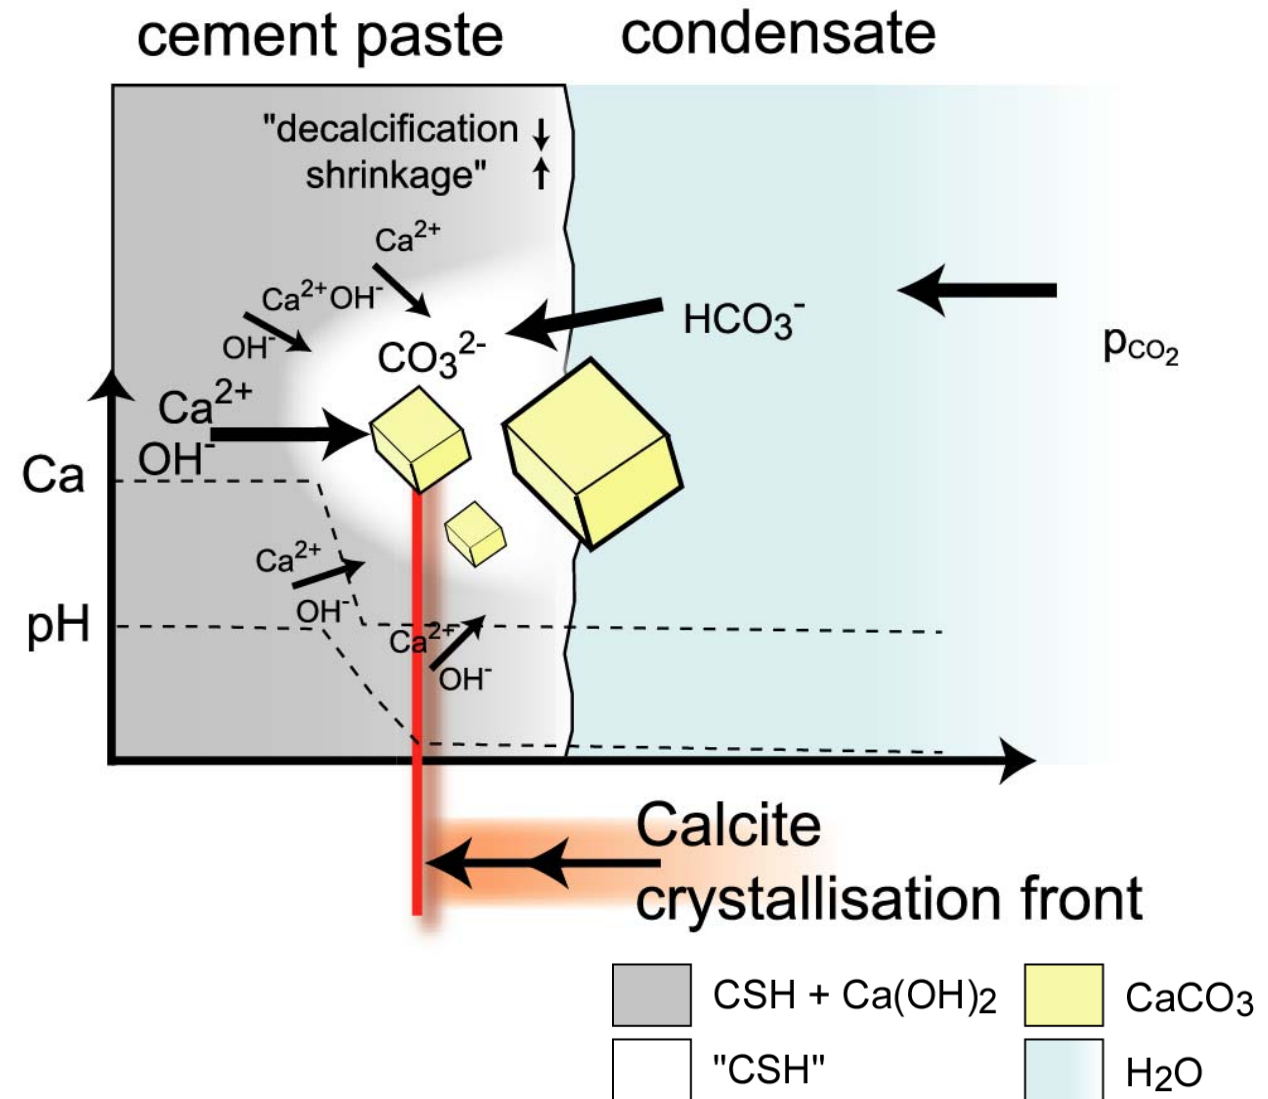
Step 1: Initial damage - material-condensate interaction

Local reaction under a condensate water drop:

In this case, the CaCO_3 -layer has no efficient function as barrier against transport processes!

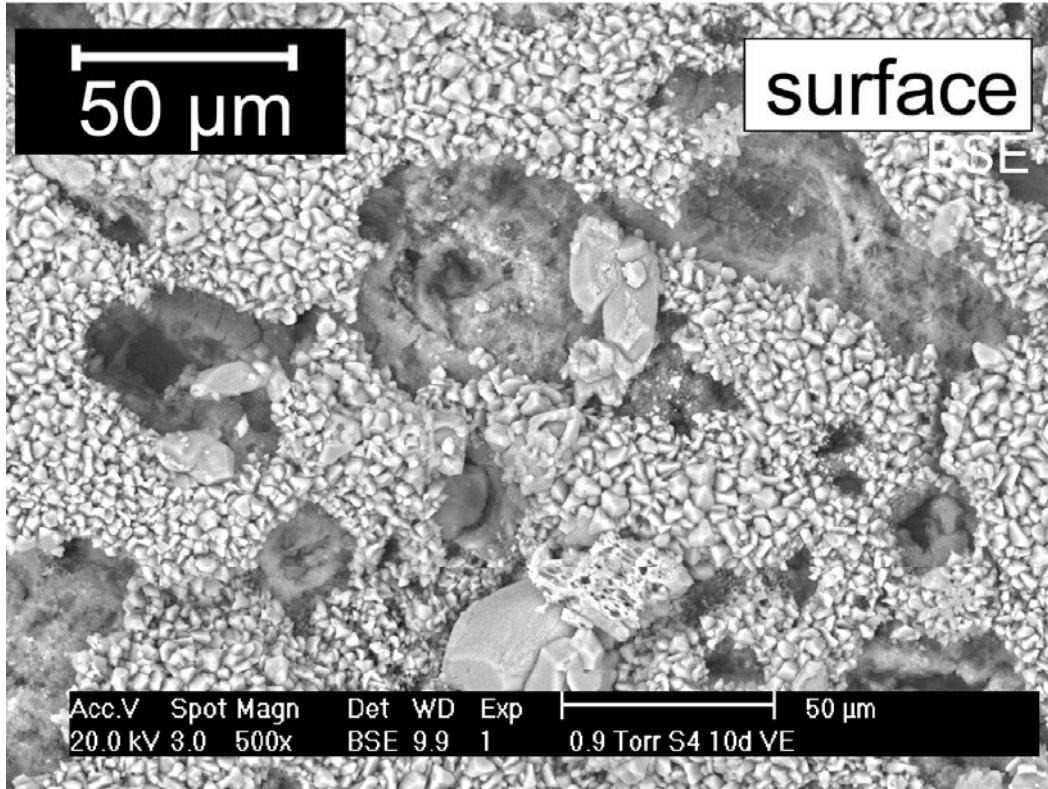
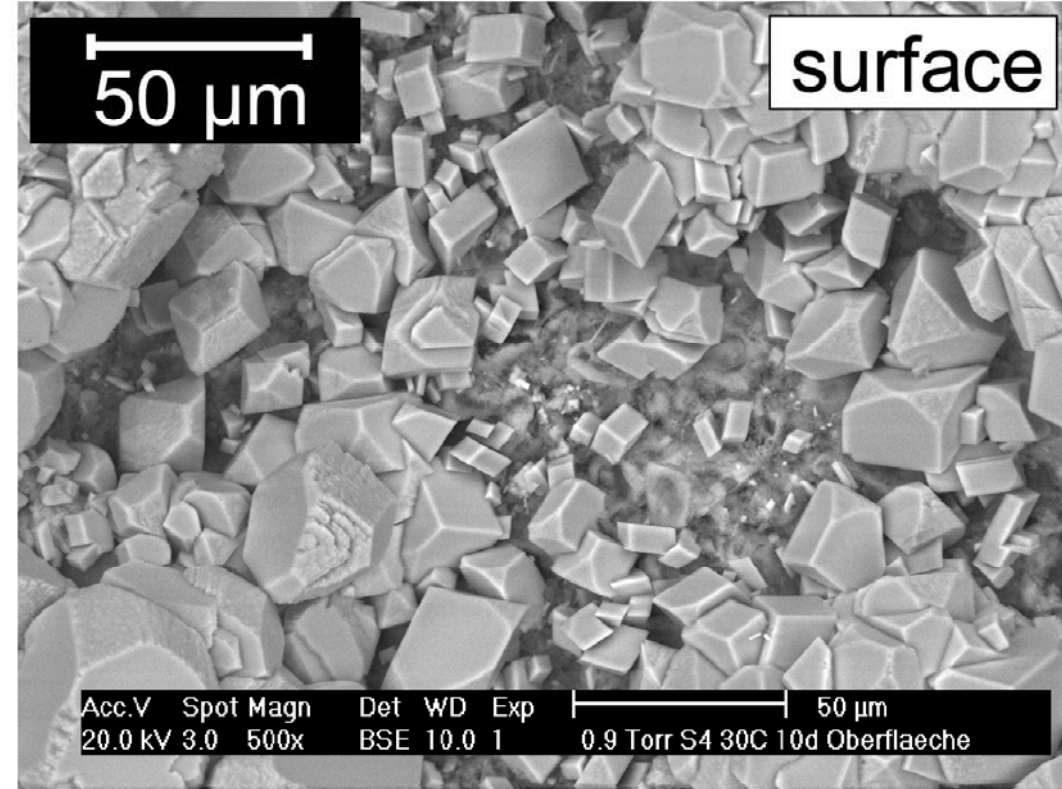
T=11°C

T=30°C

WPC paste $w/c=0.4$, 10 days stirred in demineralized water (0.5 L reactor)

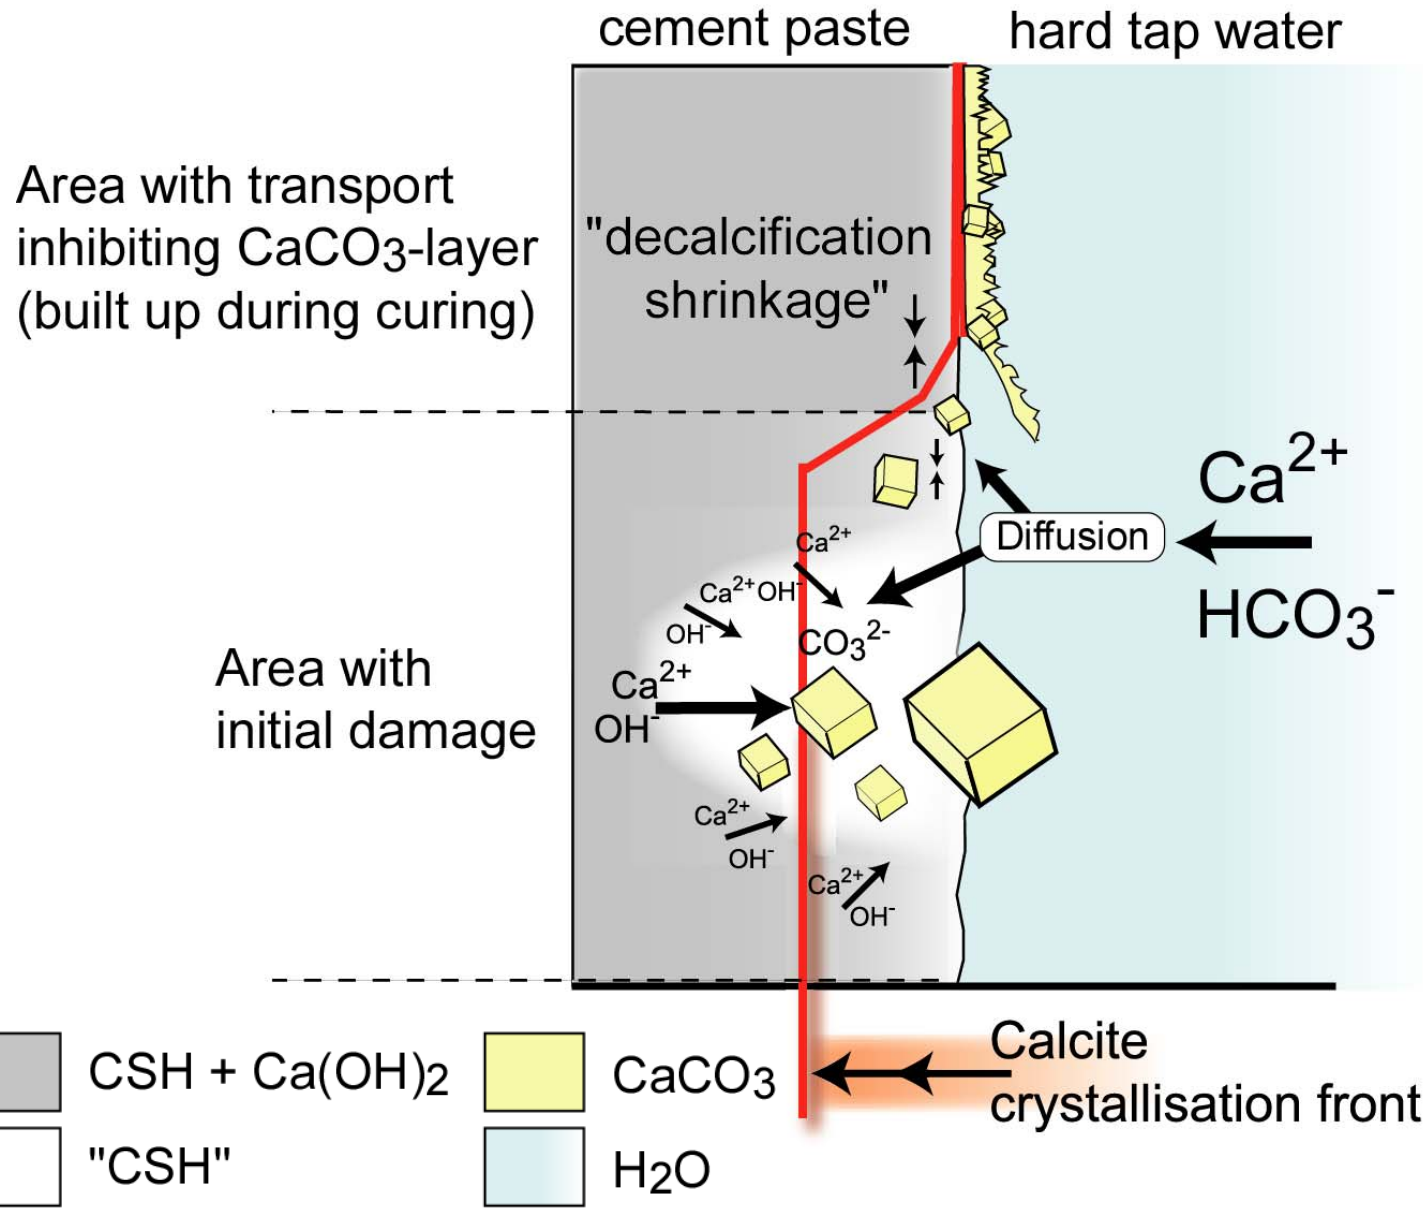
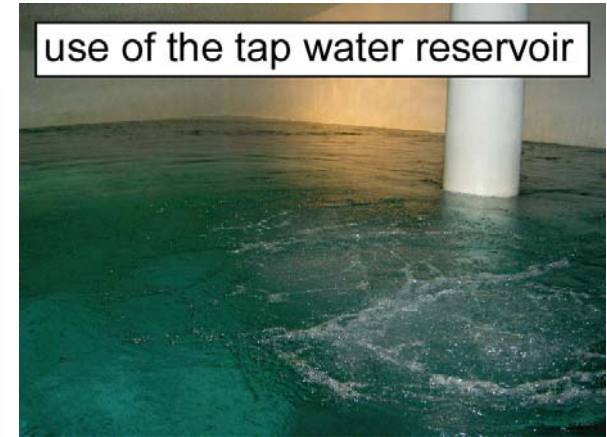
Step 2: further reaction in contact with hard tap water

Consequence: lateral- and depth-expansion of the damaged areas

(1) Initial damage by reaction with condensate

- solution of CO₂ of in the condensate
- Surface crystallisation triggers further reactive transport
- Structural changes support the progression of the reaction in deeper areas

(2) Progress of the damage during contact with hard tap water

- Crystallisation front progresses in the depth
- „Decalcification shrinkage“ promotes the lateral development of the damage

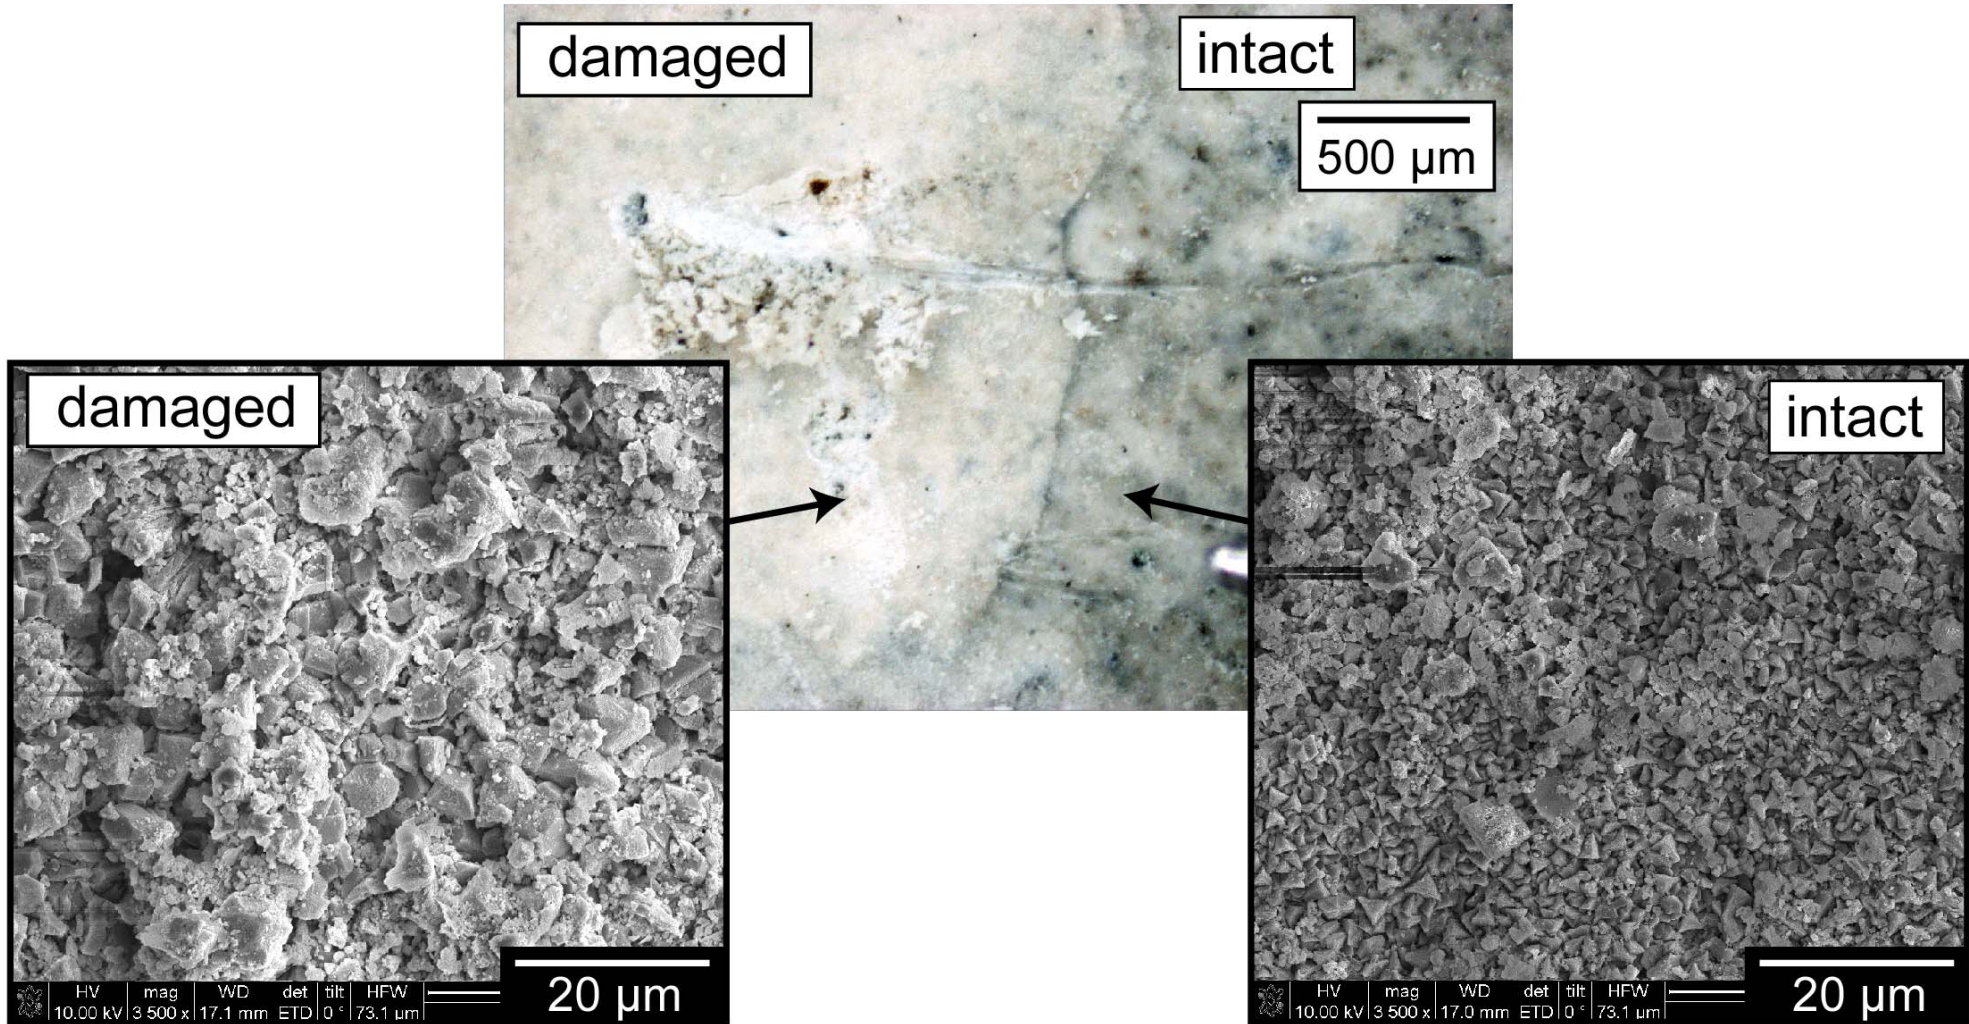
Case Study: Interface material/water

What happens in the surface near μ -meters?

Focused Ion Beam preparation of a deteriorated area (white) and an intact area (gray)
