CEMENT-BASED MATERIALS IN CONTACT WITH WATER – REACTIVE TRANSPORT DRIVEN BY SURFACE PROCESSES –

M. Schwotzer¹, T. Scherer², A. Gerdes^{1,3}

¹ Forschungszentrum Karlsruhe, ITC-WGT

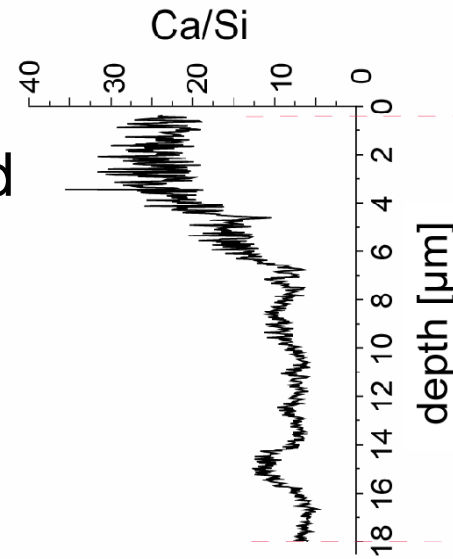
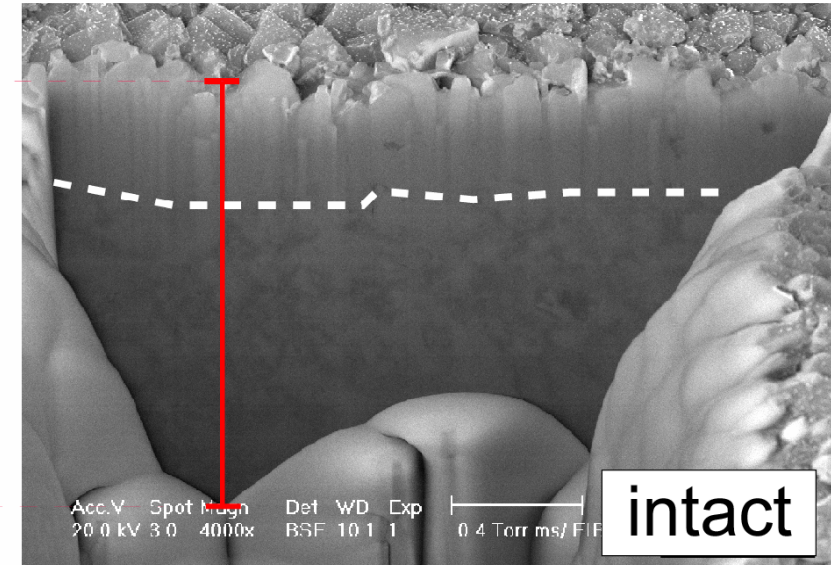
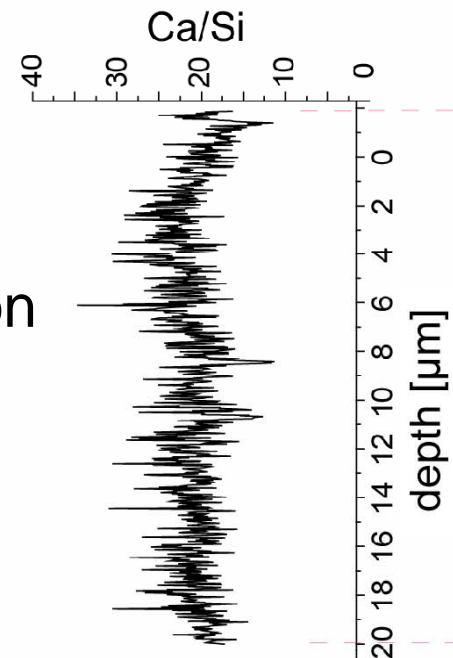
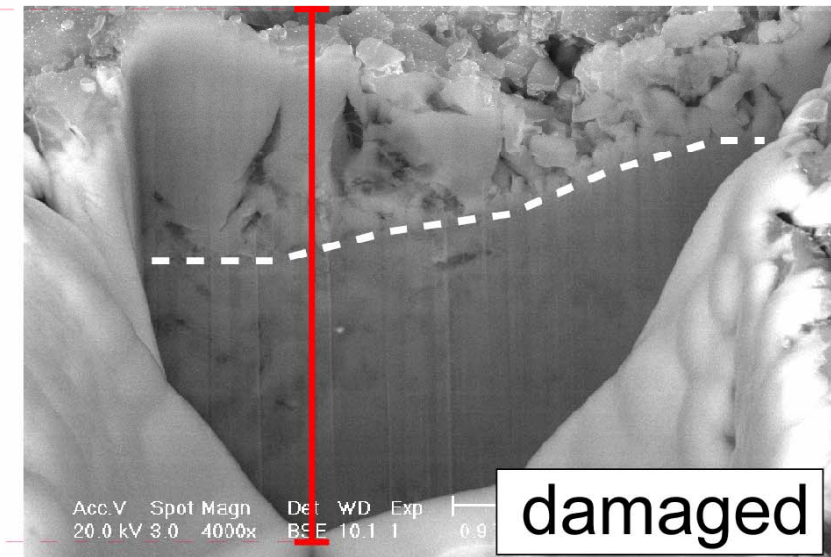
Case study: Interface material/water

EDX-analysis on FIB-cuts
in the surface of a damaged and
a intact mortar surface

- **Structure of CaCO_3 layer**
Irregular in the damaged area

- **Ca/Si ratio**
In the **intact** area, the CaCO_3
layer is only few μm thick
In **damaged** area, the formation
of CaCO_3 has reached deeper
regions of the material

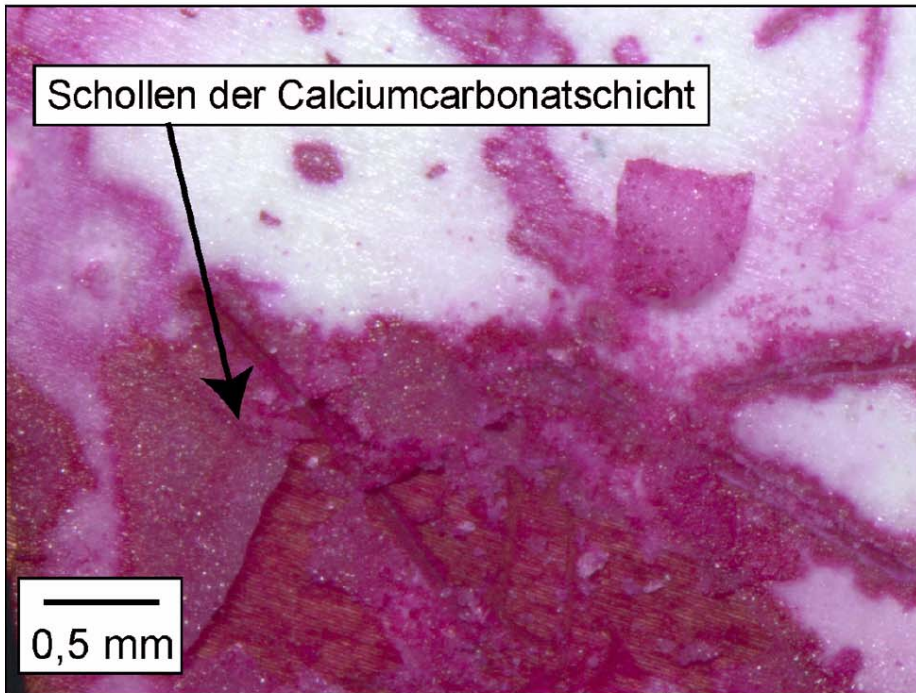
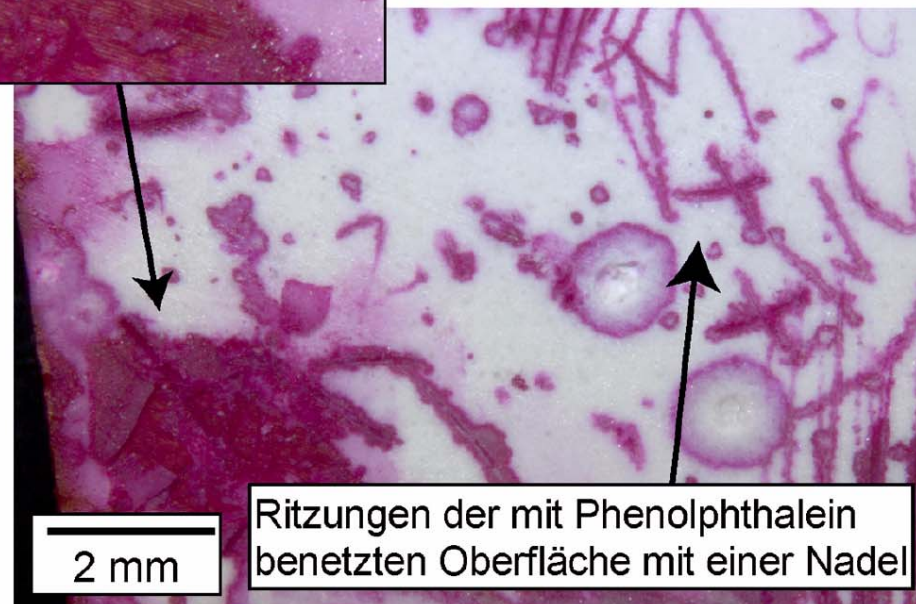
1. Phenolphthaleinlösung wurde auf die Oberfläche aufgebracht: Keine signifikante Farbreaktion

Calciumcarbonatschicht unterbindet den Kontakt der Indikatorlösung mit der alkalischen Porenlösung des Zementsteins.

2. Anritzen der Oberfläche mit einer Nadel:

Im Bereich der Ritzung tritt violette Verfärbung auf

Nur in Bereichen, die mit einer Nadel angeritzt wurden, konnte die Indikatorlösung in Kontakt mit der alkalischen Porenlösung (pH ~12) des unter der Calciumcarbonatschicht liegenden Zementsteins kommen.

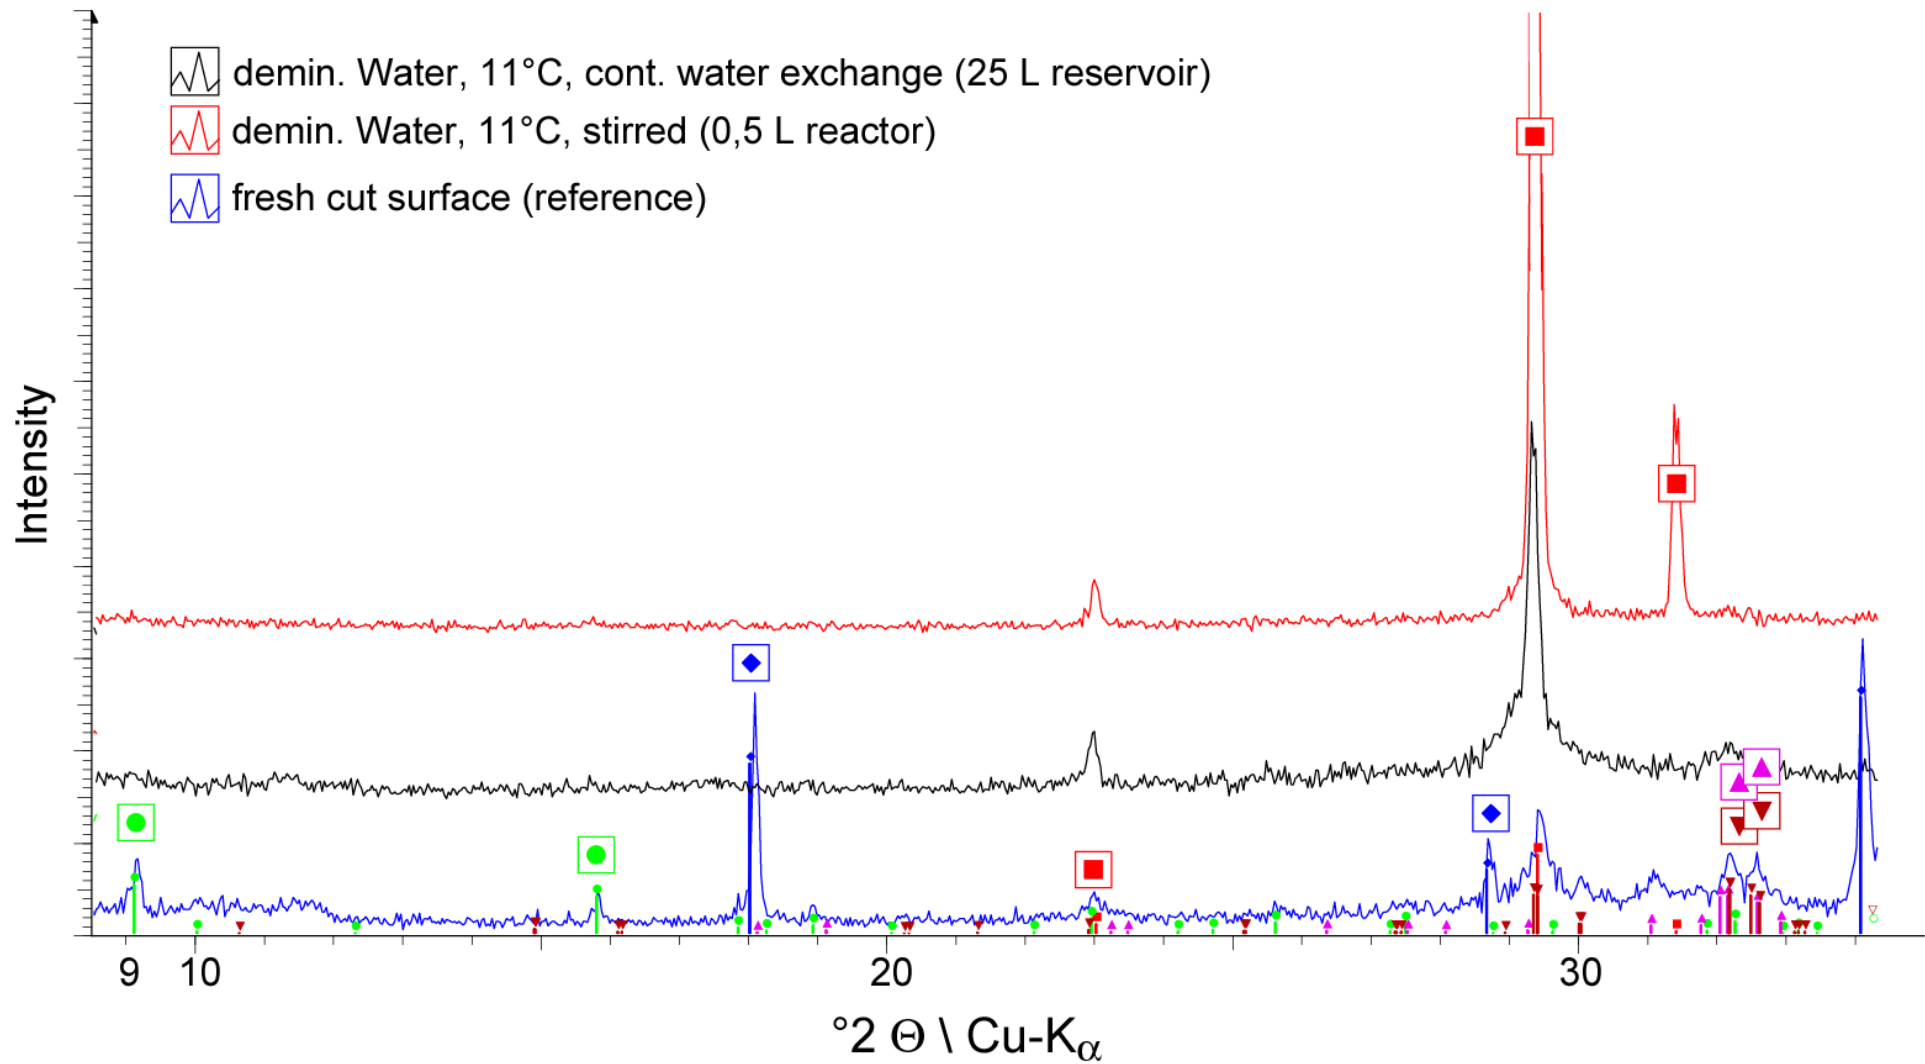
XRD of the sample surfaces

demin. Water, 11°C, cont. water exchange (25 L reservoir)
-

demin. Water, 11°C, stirred (0,5 L reactor)
-

fresh cut surface (reference)

05-0586 (*) - Calcite, syn - CaCO₃
-

44-1481 (*) - Portlandite, syn - Ca(OH)₂
-

41-1451 (*) - Ettringite, syn - Ca₆Al₂(SO₄)₃(OH)₁₂ · 26H₂O
-

33-0302 (*) - Larnite, syn - Ca₂SiO₄
-

86-0402 (C) - Hatrurite, syn - Ca₃SiO₅

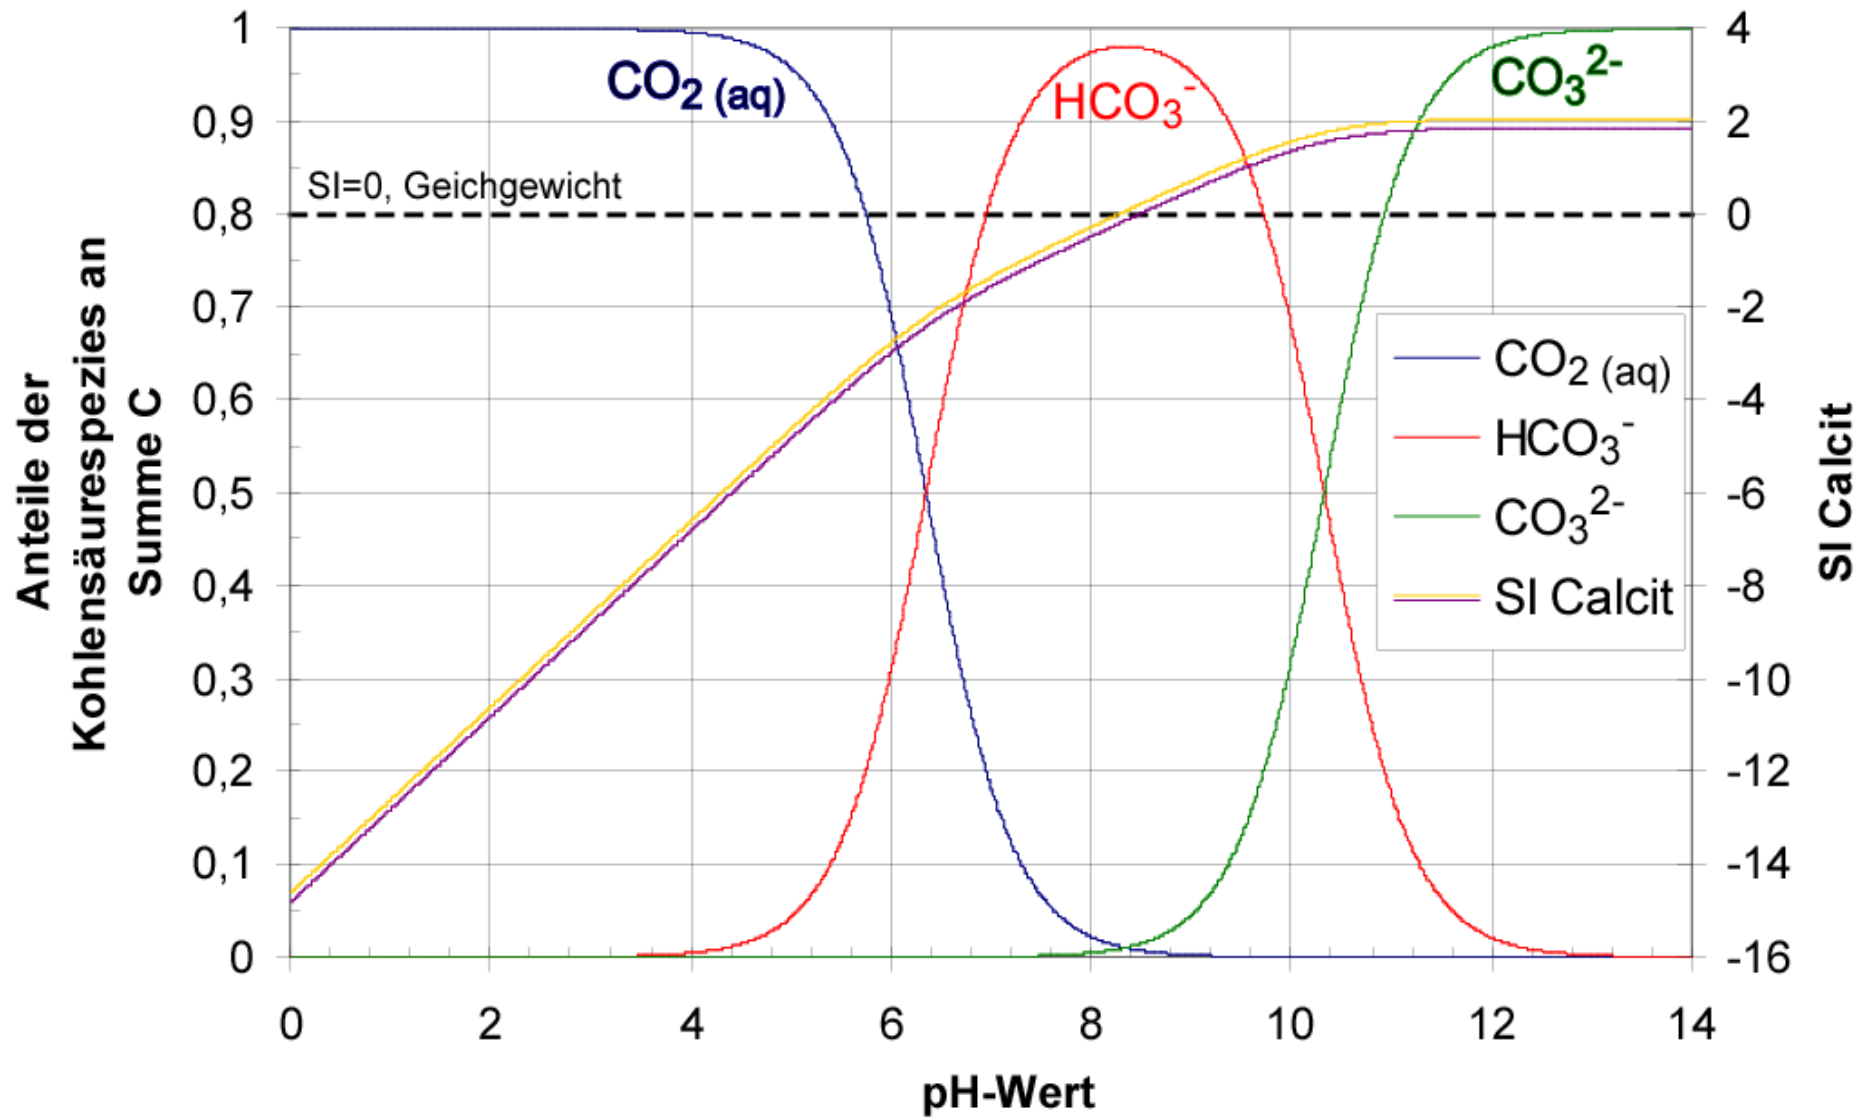
Sättigungsindex Calcit (SI)

(bei pH 7.5, TA 3.5 mmol/L, Ionenstärke: 11 mmol/L, c(Ca): 2,5 mmol/L)
